This errata sheet provides updated information about known device issues affecting Arria® II GZ devices.

## Introduction

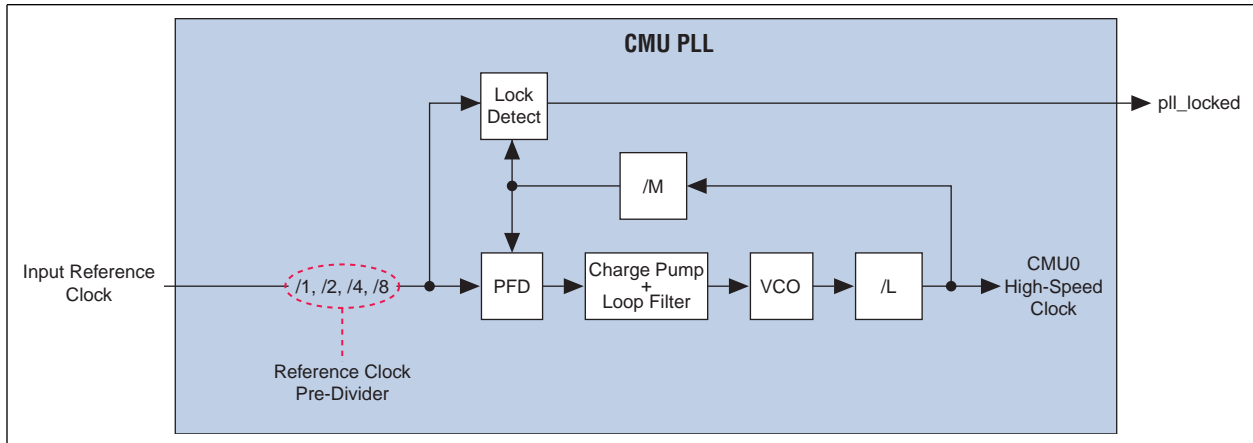
**Figure 1. Reference Clock Pre-Dividers in Transmitter PLLs**

The transmitter phase-locked loop (PLL) lock status signal (pll\_locked) does not de-assert when the pll\_powerdown signal is asserted in configurations that use the reference clock pre-divider of 2, 4, or 8. Figure 1 shows the reference clock pre-divider inside transmitter PLLs. This issue impacts the pll\_locked status signal in the clock multiplier unit (CMU) PLL.

If the pll\_locked issue impacts your design, instantiate and connect the pll\_locked\_soft\_logic module, as shown in Figure 3. You must use the pll\_locked\_to\_corelogic output from this module in the transceiver reset logic and any user logic that relies on the transmitter PLL lock status signal.

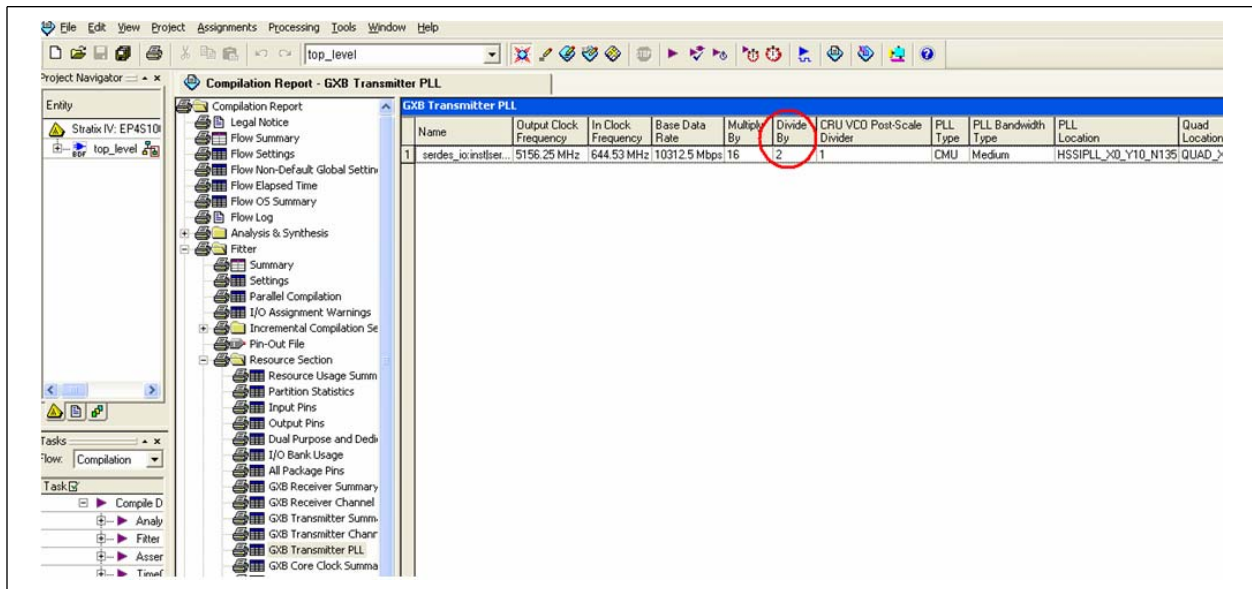
**Figure 2. Determining Reference Clock Pre-Divider Value in the Compilation Report**

You can determine if the Transmitter PLL in your design uses a reference clock pre-divider of 2, 4, or 8 by referring to the Quartus II software Compilation Report. Figure 2 shows an example of the "GXB Transmitter PLL" report, which you find in the "Resources Section" under "Fitter" in the Compilation Report. If the value in the "Divide By" column reads 2, 4, or 8, your design is impacted by the pll\_locked status signal issue.
