This errata sheet provides updated information on known device issues affecting Cyclone® IV devices.

Table 1 lists specific Cyclone IV issues and which Cyclone IV devices are affected by each issue.

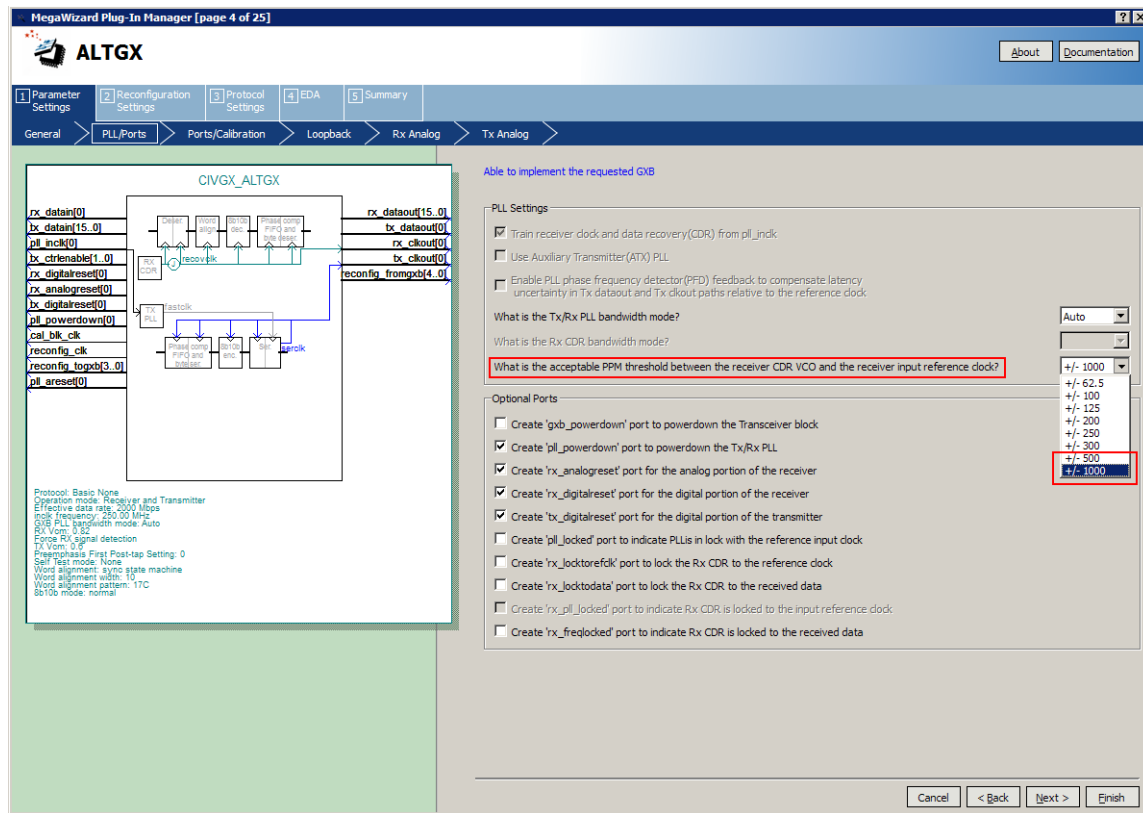
Figure 1. Programmable PPM Detector Options in the ALTGX MegaWizard Plug-In Manager

The  $\pm 500$  PPM and  $\pm 1000$  PPM options for the Programmable PPM Detector feature in the ALTGX MegaWizard™ Plug-In Manager, as shown in [Figure 1](#), are no longer supported in the Quartus II software version 10.0 SP1 and later. These options are removed because the programmed PPM threshold values exceed the receiver CDR PPM tolerance between the upstream transmitter reference clock and the local receiver reference clock.

Figure 1 shows the Programmable PPM Detector options in ALTGX MegaWizard Plug-In Manager in the Quartus II software, version 10.0.

Designs compiled with the Quartus II software version 10.0 and earlier may have a link failure risk when the receiver is operating in a system that has  $\pm 500$  PPM or  $\pm 1000$  PPM differences for the reference clock frequencies between the upstream transmitter and the local receiver. Using CDR Manual Lock mode does not overcome the link failure risk.

For a receiver design that has the  $\pm 500$  PPM or  $\pm 1000$  PPM options selected in the Programmable PPM Detector feature, Altera recommends evaluating the system operation with different options, ranging between  $\pm 62.5$  PPM and  $\pm 300$  PPM. To change the **Programmable PPM Detector** option, regenerate and recompile the ALTGX MegaWizard Plug-In Manager design file with the supported options.
